# Geomorphological changes caused by Tsunami 2004 in the coastal environment of Weligama Bay in Southern Sri Lanka

**Abstract:** The coastal area of Weligama Bay was severely affected by the tsunami disaster on 26<sup>th</sup> of December 2004. It caused 396 deaths locally in addition to the destruction of valuable properties. Also most of the geomorphological features have been altered severely. The objective of this study was to examine how the tsunami waves have impacted on geomorphological features in Weligama Bay.

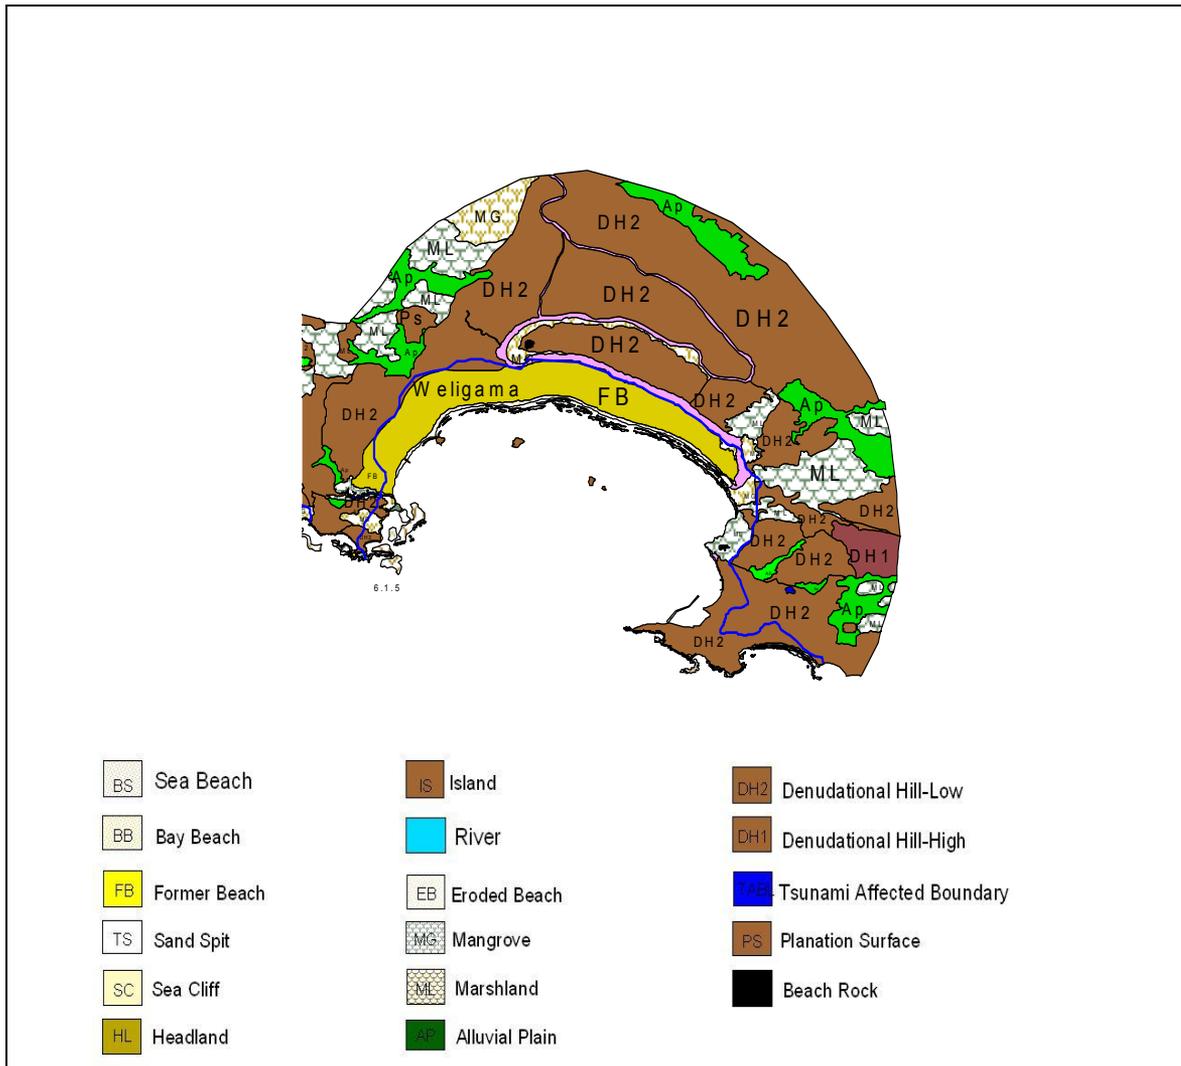
**Figure 2:** Geomorphologic map of Weligama Bay area

This area consists of coastal landforms originated through various kinds of processes. There are bay beaches and allied features, bay and headlands, estuaries, beach rocks, alluvial plains, fluvio-marine plains, denudational hills and planation surfaces (See Figure 2). These originate due to the influence of marine, fluvial, fluvio-marine and denudational processes (Wijeratne, 2009).

Source: This map was compiled based on Ikonos satellite images taken by Urban Development Authority, 2005.

Although these landforms have contributed to preserve the coastal environment, most of them were completely or partially damaged even before the tsunami waves affected them. Marine landforms were highly affected by the tsunami waves. Bay beach, estuary, sand spits, beach rocks, headlands, sea cliffs and coastal structures are the specific coastal landforms which were heavily damaged and changed by tsunami. They could be identified by the interpretation of pre and post tsunami satellite images using Geographical Information System (GIS) and also they were compiled through geomorphologic maps (see Figure 02).

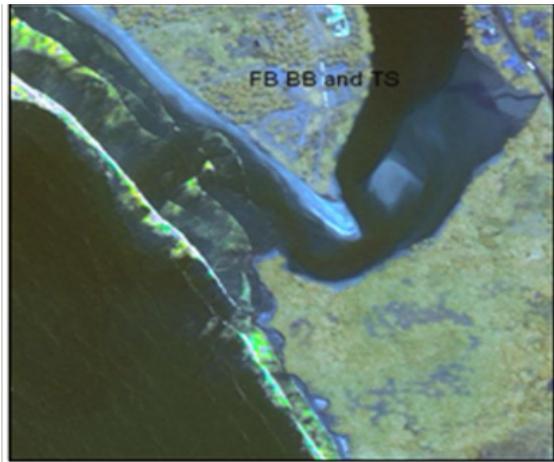
Figure 3: Polwatta Ganga estuary-before tsunami

Polwatta Ganga is the major river flowing across the Weligama Bay. This river flowing with meandering towards the north of the coastline approaches the sea, close to the Pemuyana headland. Estuary, sandspit, sea cliff, mangrove, former beach and beach rocks are the landforms distributed around the Polwatta Ganga estuary and most of them were impacted by the tsunami. Because of the tsunami waves, the estuary was affected only marginally. To the north of the estuary, the breadth was increased by about 5 m and also, the breadth of sand spit of the estuary was increased by about 2 m. Around 5000-6000 years ago, the Holocene sea level was accelerated by 1 m and it created river meanders as an upward movement of the river (Weerakkody, 1990). Not only the long-term sea level rise, but also a sudden sea level rise caused by tsunami, storm waves produced

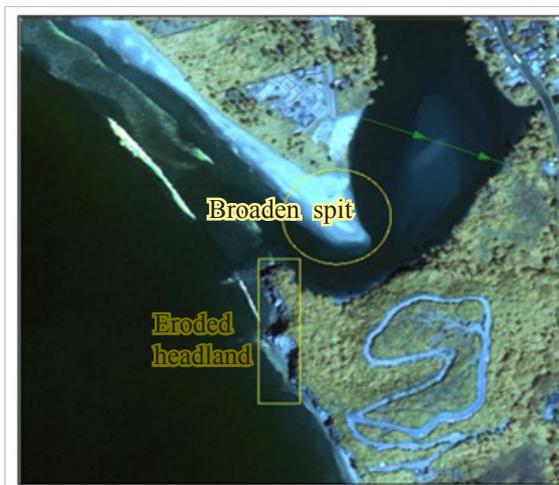
Figure 4: Changes of Polwatta Ganga estuary-after tsunami

Tsunami waves penetrated 500 m inland and river meandering obstructed further flow of water towards the upper areas. Because of these disturbances, river banks were sedimented with marine deposits and it damaged the mangroves about 5 m along both the river banks.

The sand spit of the estuary was developed by tsunami and sand accumulated on flood plain of the both sides of the river banks by about 2 feet in thickness. Sand spit was spread by 2 m and north of the estuary was broadened by 2 m and deepened by 1 m. By this time, landscape of the river outfall has been changed by the re-development of a sand barrier. But, basement of the sea cliff has eroded up to 15 m in height, as the tsunami waves attacked on the cliff base. However, the damage to the estuary was

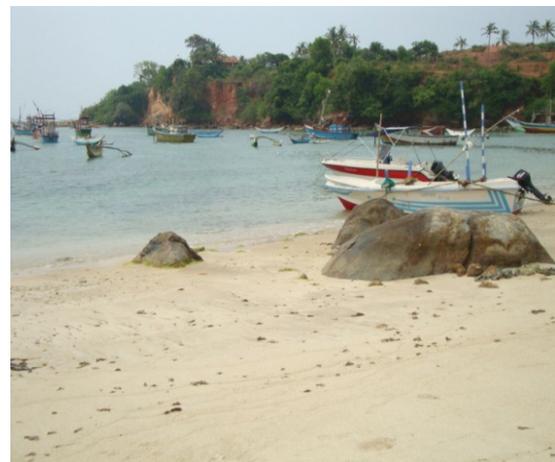
Figure 5: Prograded beach after tsunami by accumulation of sand-Kapparatota

The bay was geomorphologically changed because of sand deposition on the northern part of it. Tsunami waves refracted towards the north-west of the bay, and the northern part of the bay beach was formed further with beach materials transported by the tsunami waves from south to north direction. It has resulted in a broadened beach of about 15 m in width and former offshore coast had changed into a sandy beach now. As a result of this, at present it is clear, that the Kapparatota natural harbor has changed into a bay beach area (See Figure 5 and 6).

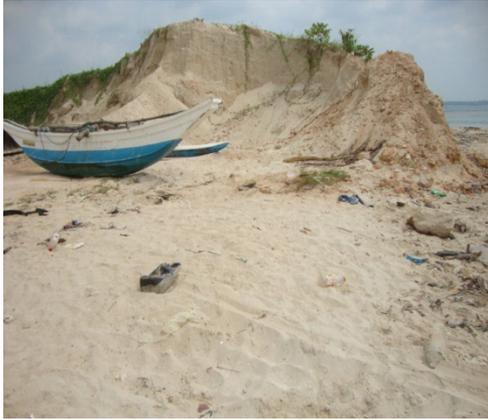
**Figure 6:** Collected sand deposits- Kapparatota harbor

The bay was geomorphologically transformed because of sand deposition on the northern part. As a result of this, the Kapparatota natural harbor which was located in the northern part of the bay has been turned into a bay-beach by sand deposition. Accordingly, among the changes of geomorphologic features that could be identified, bay-beach, river outfall, sand spits and marshlands are the most severely impacted coastal features.
